Draft minutes of the Annual Meeting of the Pontyclun Town Council held at 7.00 p.m. on Thursday 9th May 2024 and the May monthly meeting of the Council held directly after completion of the Council's Annual meeting.

Pontyclun Traffic issues

We have also received a copy of the most recent survey on Brynsadler bridge which is attached as appendix 2a. Members can see there are a number of minor issues. The one main problem is a tree which is potentially undermining the bridge at land at the Hollies. The Clerk has checked and this is not on our land.

Structure: BRYNSADLER RIVER BRIDGE	Structure Ref: 165002	Form: 1 of 1
---	------------------------------	---------------------

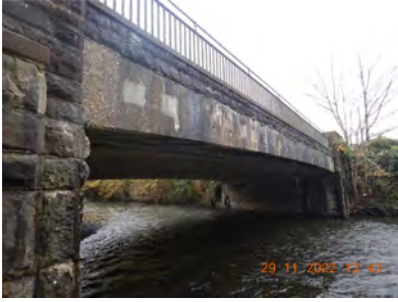
Spalls to both edge beams at transverse end
1	2300513

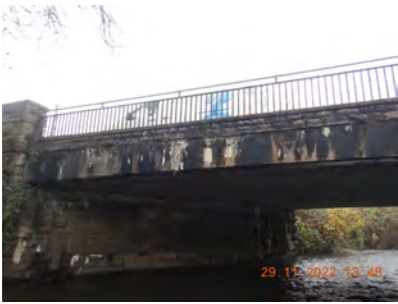
Leachate staining to deck between outer edge beams
1	2300514

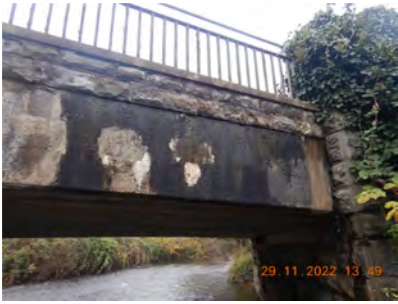
Spalls to both edge beams at transverse end
6	2300515

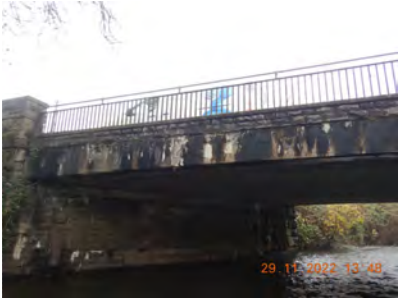
Staining and spalling to outer edge beams
6	2300516

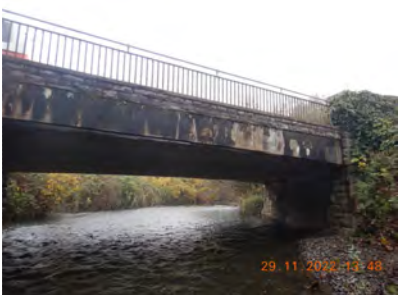
Minor hairline cracks to parapet beams

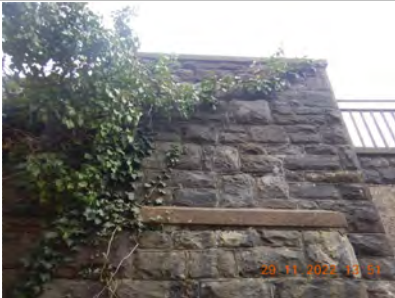
Ivy growth to pillaster north east
9	2300522

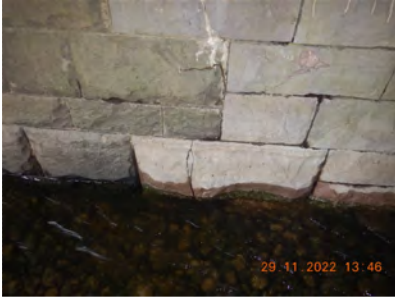
Vertical crack at the centre of east abutment
9	2300523

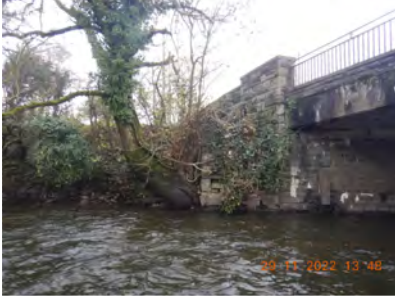
33	Embankments	3	C	5.1		L	Tree adjacent to bridge on downstream west and upstream west embankments causing structural damage to west abutment.

Large tree growth causing structural damage to west abutment downstream.
9	2300524

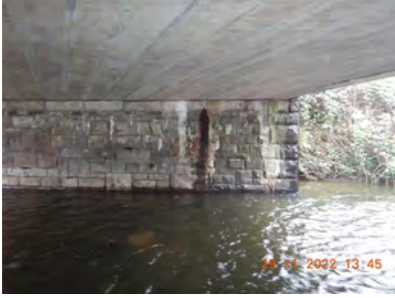
Loss of pointing and staining to west abutment
9	2300525

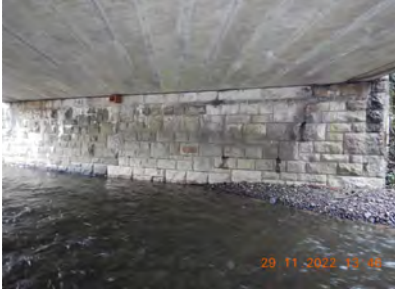
Joint wash out to masonry abutments

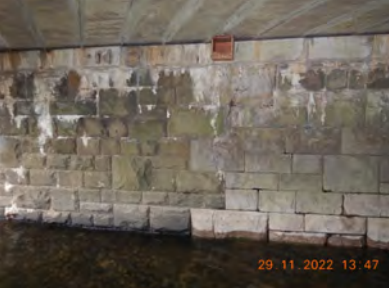
Staining and spalling to with exposed reinforcement to padstones
14	2300527

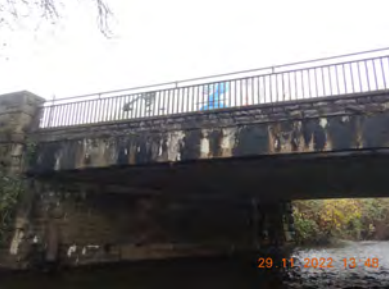
Staining and spalling to outer edge beams
17	2300528

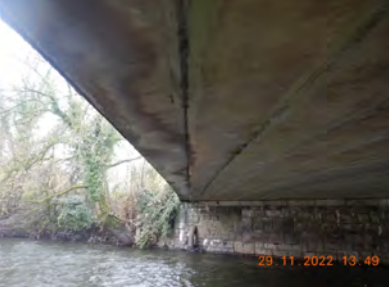
Leachate staining to deck between outer edge beams
17	2300529

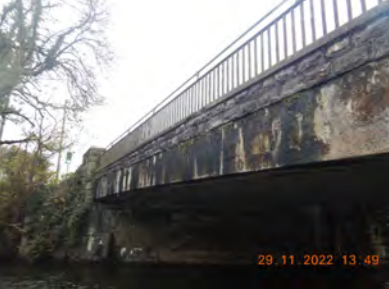
Leachate staining to deck between outer edge beams
18	2201090

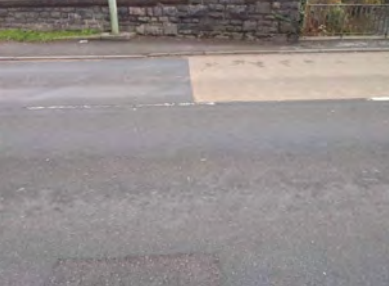
Cracking to surface over joint / east abutment

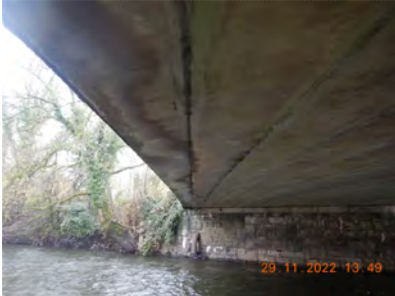
Leachate staining to deck between outer edge beams
19	2300535

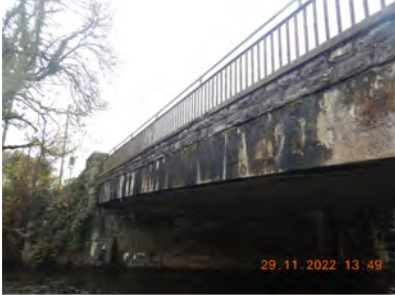
Staining to outer edge beams
19	2300536

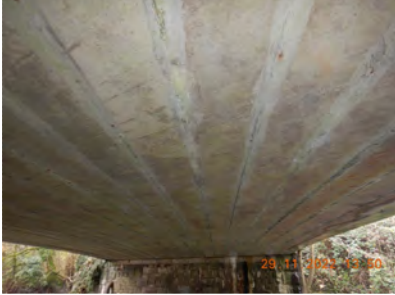
Leachate staining to deck soffit
20	2300537

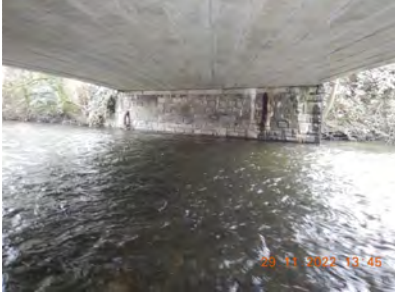
Leachate staining to west abutment
20	2300538

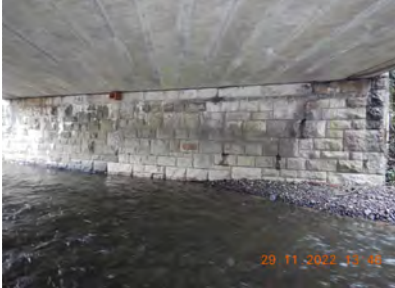
Leachate staining to abutment

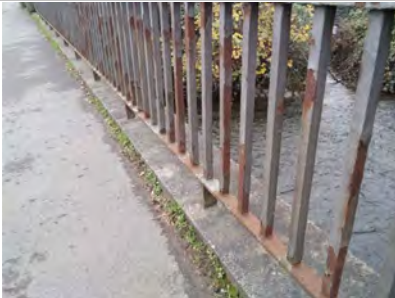
Loss of paintwork to parapet
21	2300539

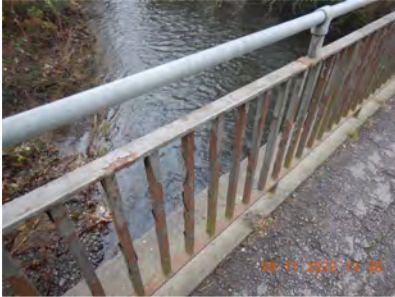
General paint loss to parapet
23	2201078

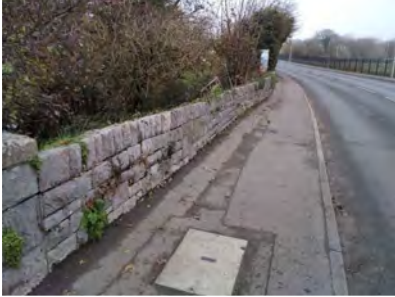
Loss of pointing to upstream east parapet.
23	2201079

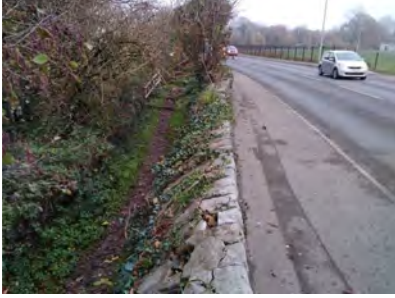
Loss of pointing and vegetation growth to approach walls
23	2300540

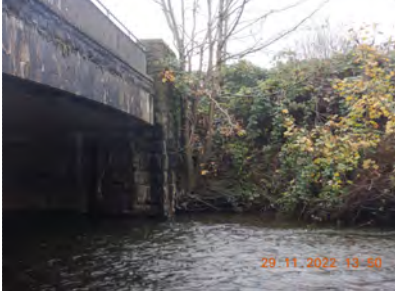
Tree growth and bulging to upstream west parapet

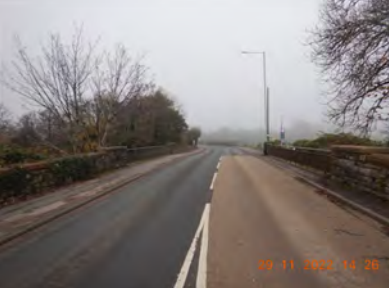
Ivy to top of parapet upstream west
23	2300544

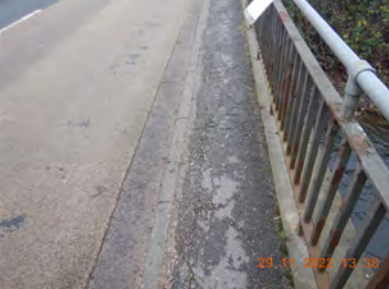
General paint loss to parapets
23	2300545

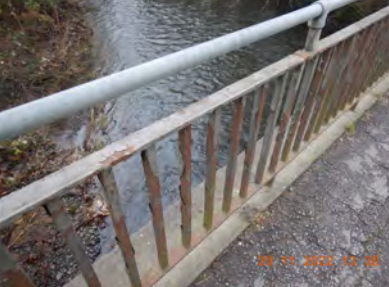
General paint loss to parapets
24	2300546

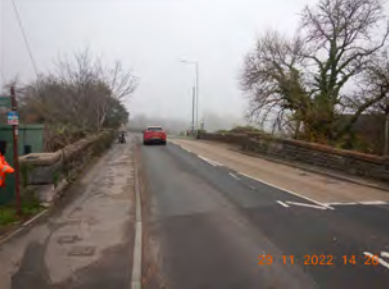
General wear to surfacing and loss of anti skid dressing in South carriageway
24	2300547

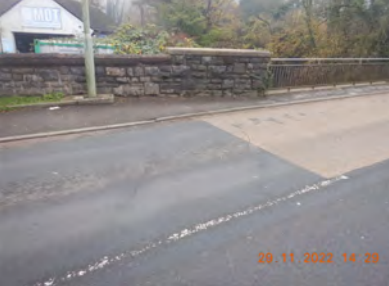
General wear to surfacing, loss of anti skid dressing south carriageway

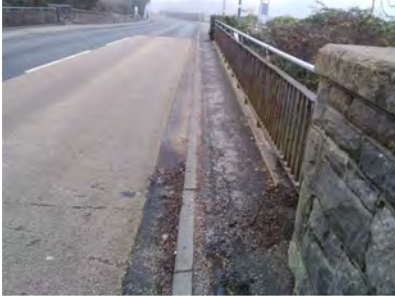
Cracks to paving
26	2300548

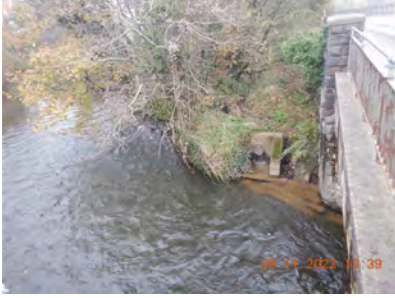
Minor scour to end of upstream east abutment
31	2201068

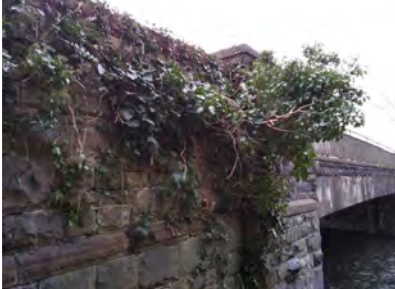
Vegetation growth on wing wall and pilaster upstream East

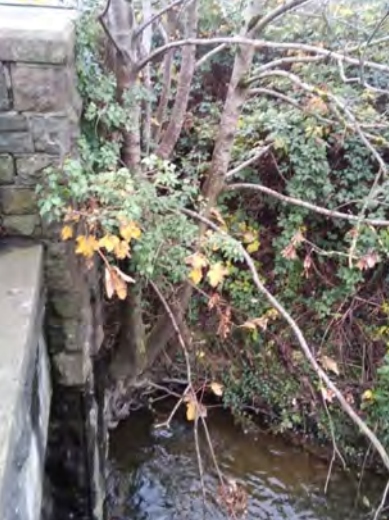
Vegetation growth to west abutment upstream
33	2201083

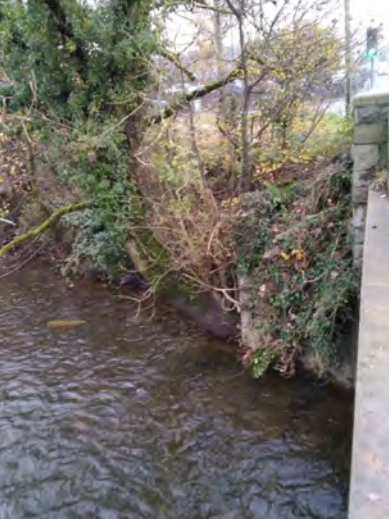
Tree adjacent to the bridge on downstream west and upstream west embankments
35	2201069

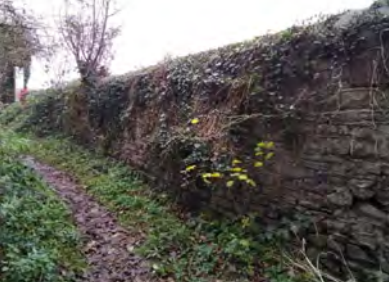
Tree and ivy growth to approach wall upstream east corner
35	2201070

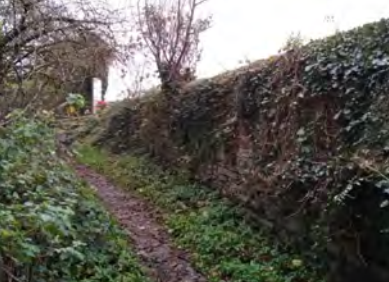
Vegetation growth to approach wall

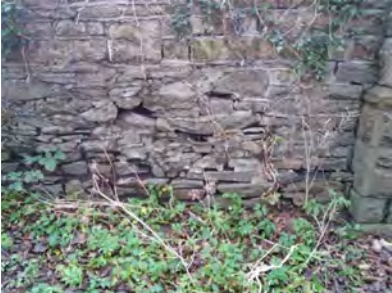
General mortar loss to masonry wall
35	2201072	 	Tree and ivy growth to approach wall upstream east
35	2201073

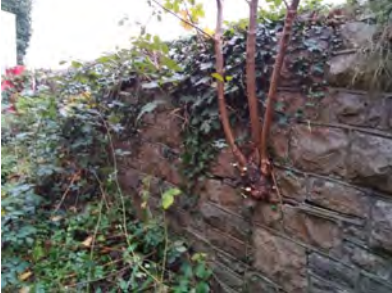
Tree growth and ivy to approach wall upstream east.
35	2201074

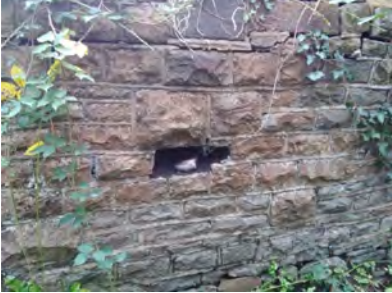
Missing masonry to approach wall
35	2201089

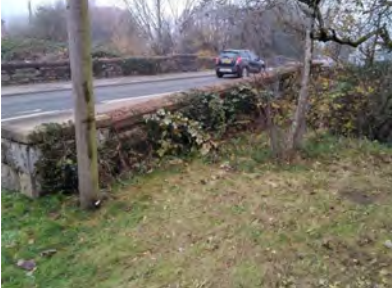
Ivy growth to approach wall downstream west
